INSPECTION OF CHURCHES MEASURE 1955

PARISH OF ST BARTHOLOMEW, THURSTASTON

DRAFT QUINQUENNIAL INSPECTION REPORT

JANUARY 2016

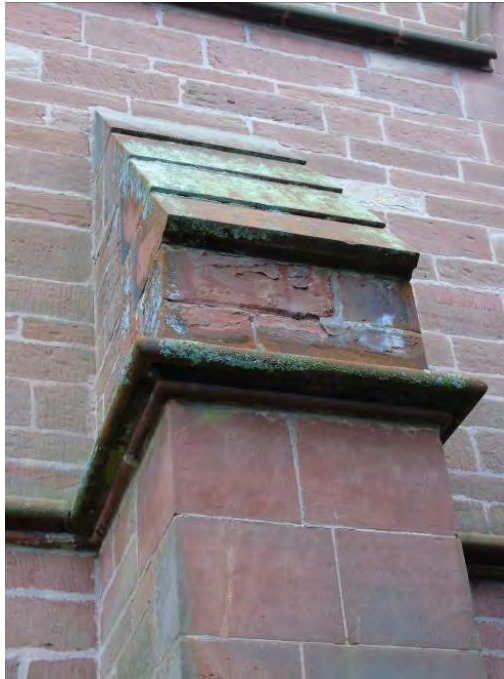
Erosion to central buttress. Note cement pointing.

Some erosion to the masonry is noted to the central buttress between the two windows to this elevation, this is presumably due to the run off from the weatherings. Some localised repointing works may be advisable. It was also noted that the wall appears to be generally pointed with a thin bed of cement mortar whereas the spalling away lime can be seen behind. Presently this isn't causing excessive erosion of the masonry.

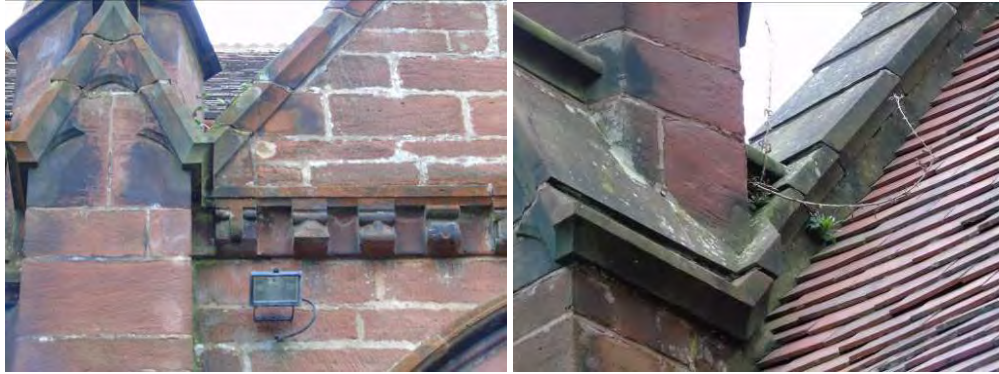
Light vegetation growth was also noted growing from coping stones, this vegetation should be removed and the coping stones repointed with lime mortar.

Vegetation growth to copings. / cement flashing to north porch.

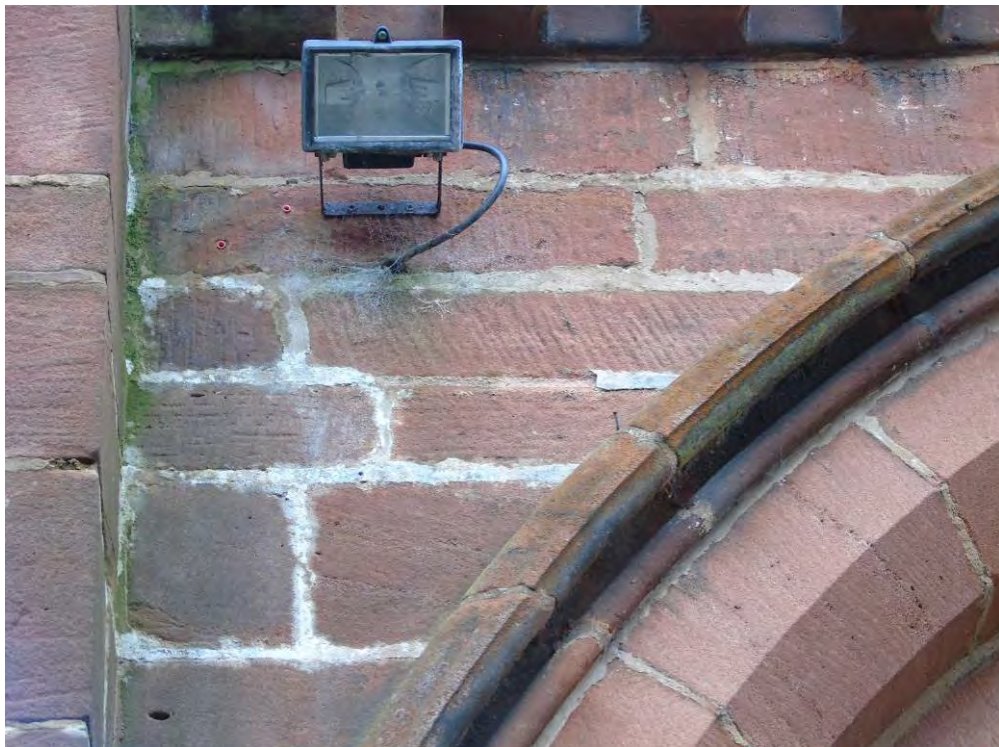
The north porch projects from the first west bay of the north side of the church and is a single bay in depth. It incorporates quatrefoil windows to both the east and west elevations and has a large arched opening with a niche above in which a statue of St Bartholomew has been placed. The gable is flanked with pinnacles. The gable is surmounted by a cross. Again the masonry has been pointed with cement mortar generally though is weathering reasonably well, however the pointing to the north elevation is spalling away as it is very thinly bedded and would ideally be removed and repointed.

Detail of shallow cement pointing that is failing.

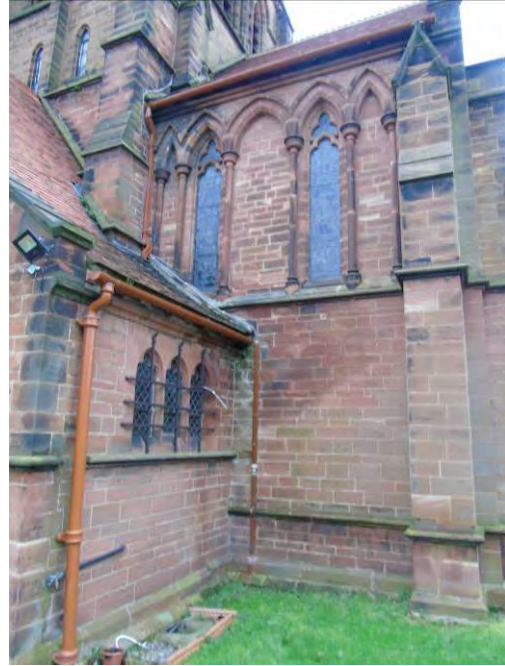
Chancel south elevation. Note water saturated masonry and vegetation growth.

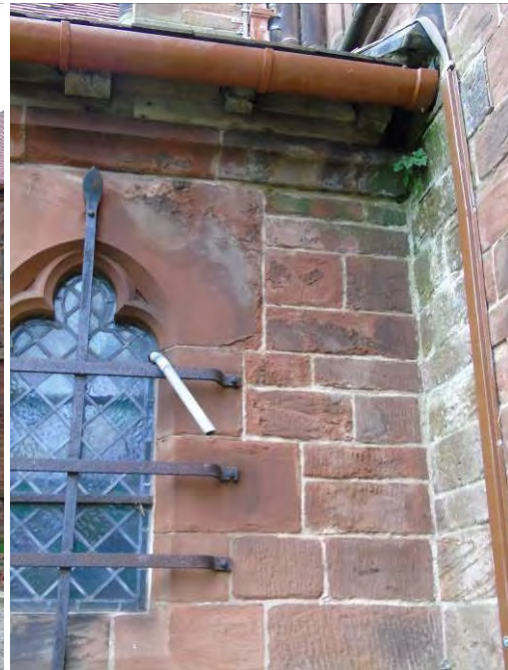
Vestry, east elevation. Water saturated masonry.

Water saturation and erosion of the masonry was noted at the abutment to the sanctuary due to the poor flashing/ weathering detail and one coping stone has spalled to the east pitch though this is sound at the present time and no work is recommended. Repointing to the saturated masonry to the east elevation should be carried out once the roofing issues are resolved and consideration should be given to repointing the south elevation gable while high level access is available.

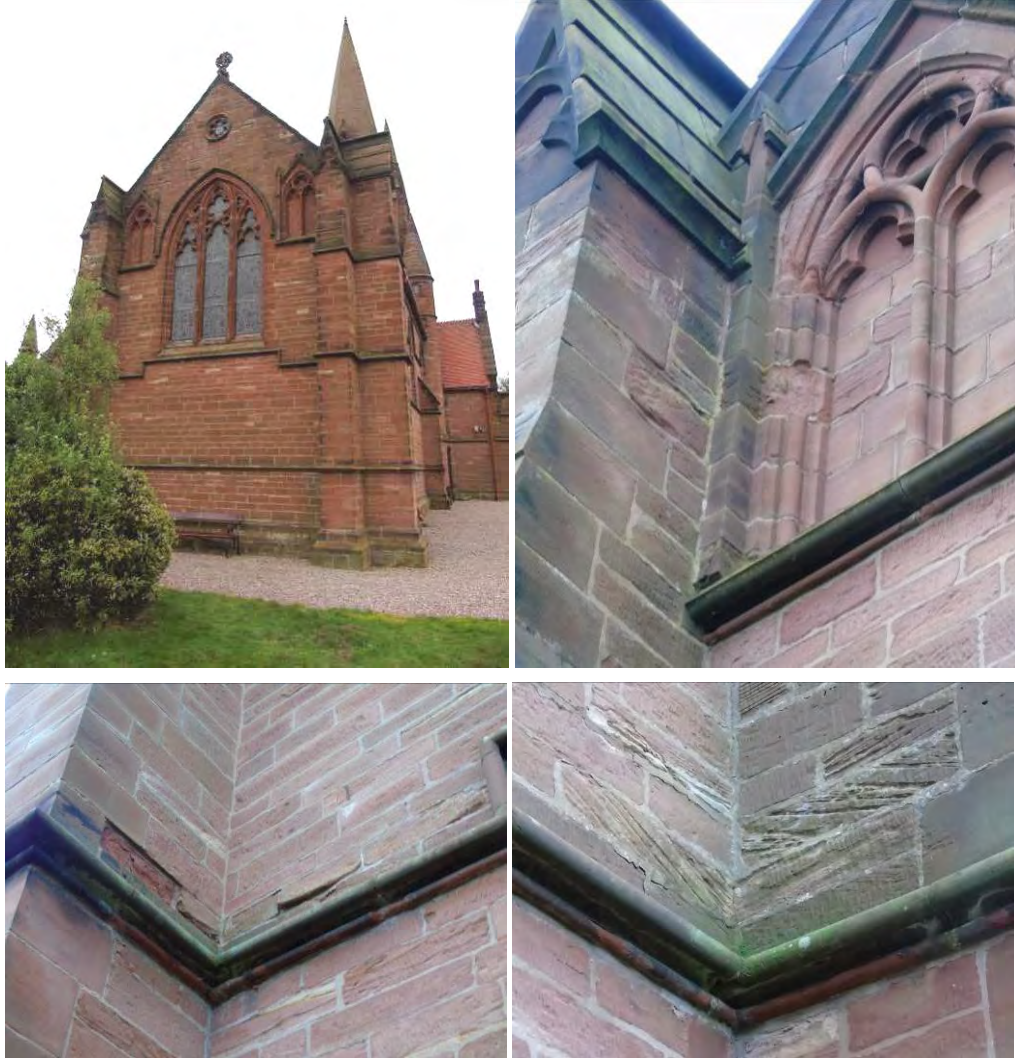
Nave west elevation and details of eroded masonry.

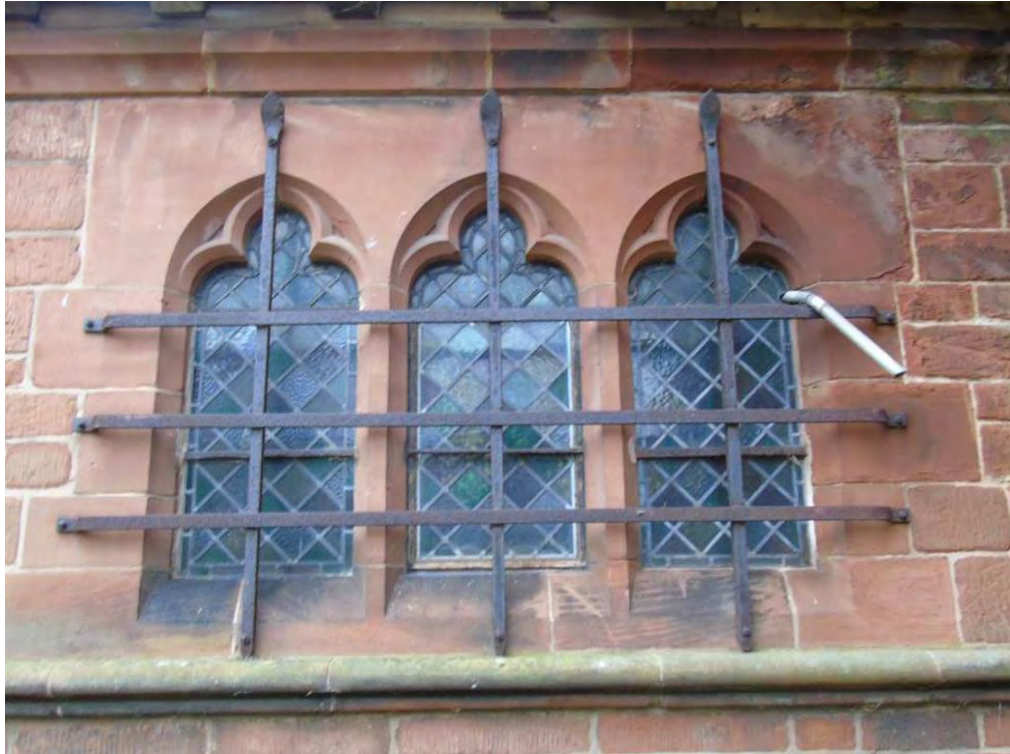
East windows to vestry. Note corrosion to iron bars / grille.

The vestry east windows have had iron bars fixed across, presumably there were issues of break-ins through these windows prior to these straps being fixed. This iron strapping is corroding slightly and in need of redecoration. Ideally this railing would be fixed across the window with the use of non-ferrous metal to prevent future spalling of the masonry.

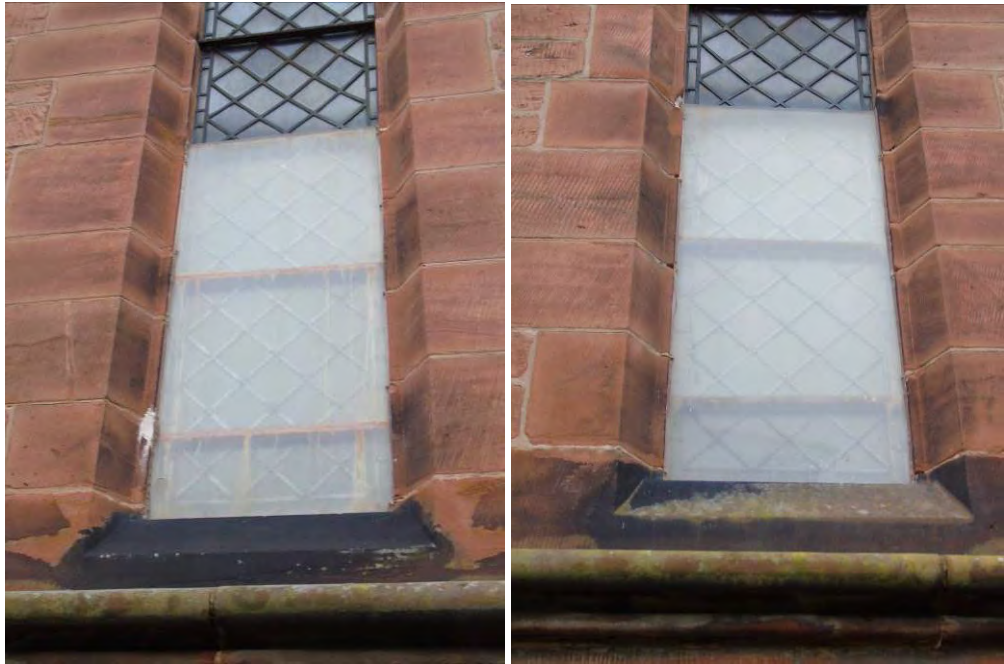
Polycarbonate sheets have also been fixed into the window openings to the lower sections of the south vestry/organ chamber windows. The reason for the application of this protection to the lower section only is unclear however it has been sealed into the window opening by the use of mastic and it is clear that the saddle bars internally between the leaded glass and the polycarbonate are corroding due to condensation. The existing polycarbonate should be removed and new polycarbonate inserted with an air gap around the perimeter supported on stainless steel fixings.

Polycarbonate window protection. Note corroding saddles bars.

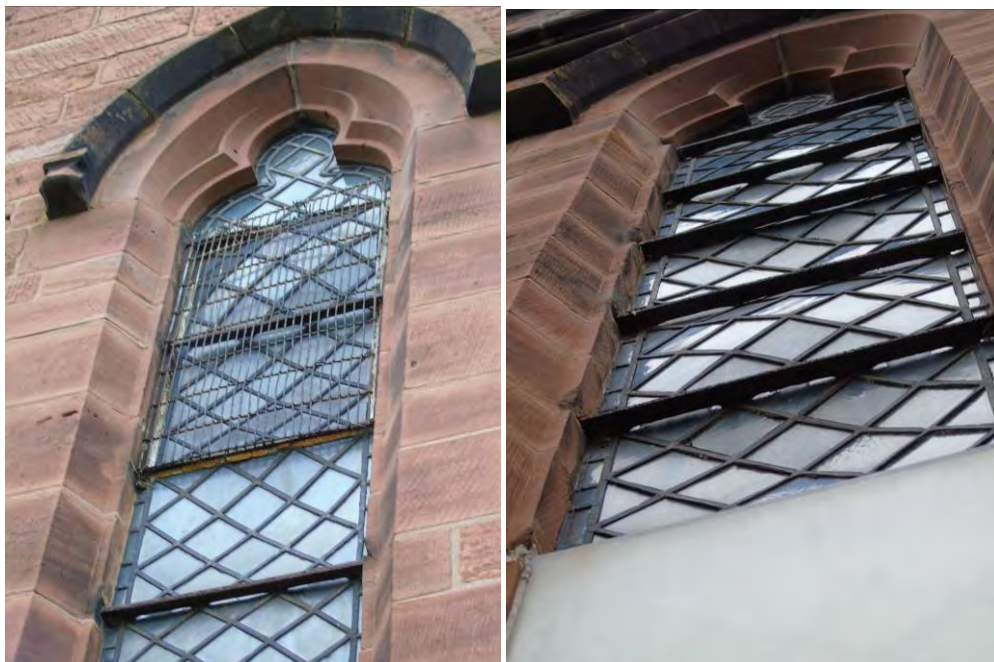
Corroding metal casement and distorted glass.

To the same south vestry windows the leaded glass to the upper two panels is set into a metal casement to which has had a wire mesh fixed across it. This wire mesh is corroding as is the metal casement frame and the glass panels appear to be heavily distorted generally. Re-leading of this glass and repair to saddle bars, removal of poor quality window protection should be considered within the Quinquennium.

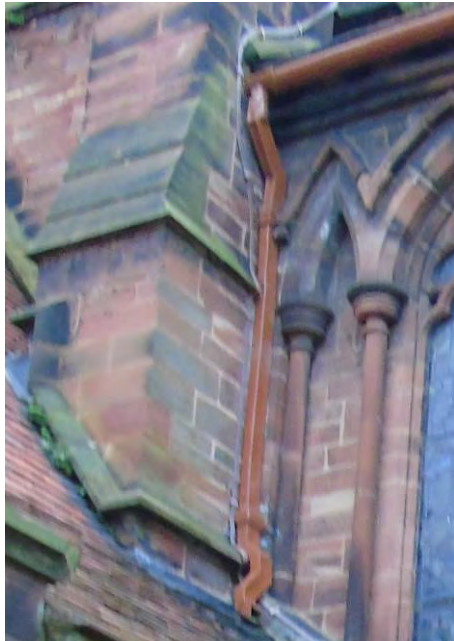
All of the rainwater goods, downpipes and gutters are of cast iron and appear to be in generally good condition, however downpipe to the south side of the sanctuary is a rectangular section as opposed to circular sections seen elsewhere. It is a particularly awkward design with many bends and twists which mean it will be prone to blocking. This could be contributing to the water saturation issues to this elevation of the sanctuary.

Detail of south sanctuary downpipe.

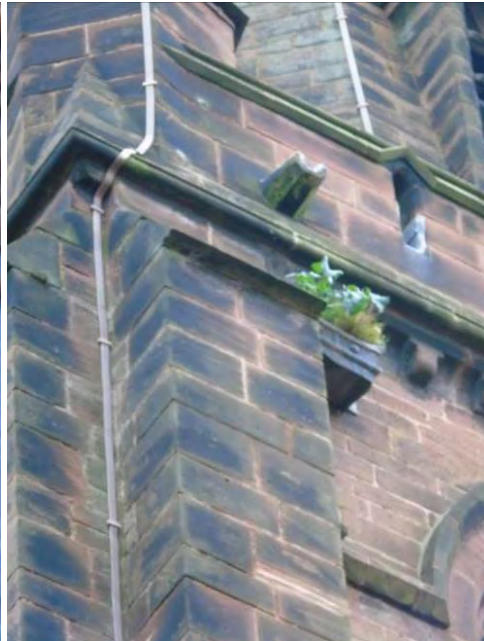
Blocked hopper to tower.

Light vegetation growth is also taking hold within the gutter to the east side of the vestry and to the hopper to the east side of the tower, all of which should be cleared.

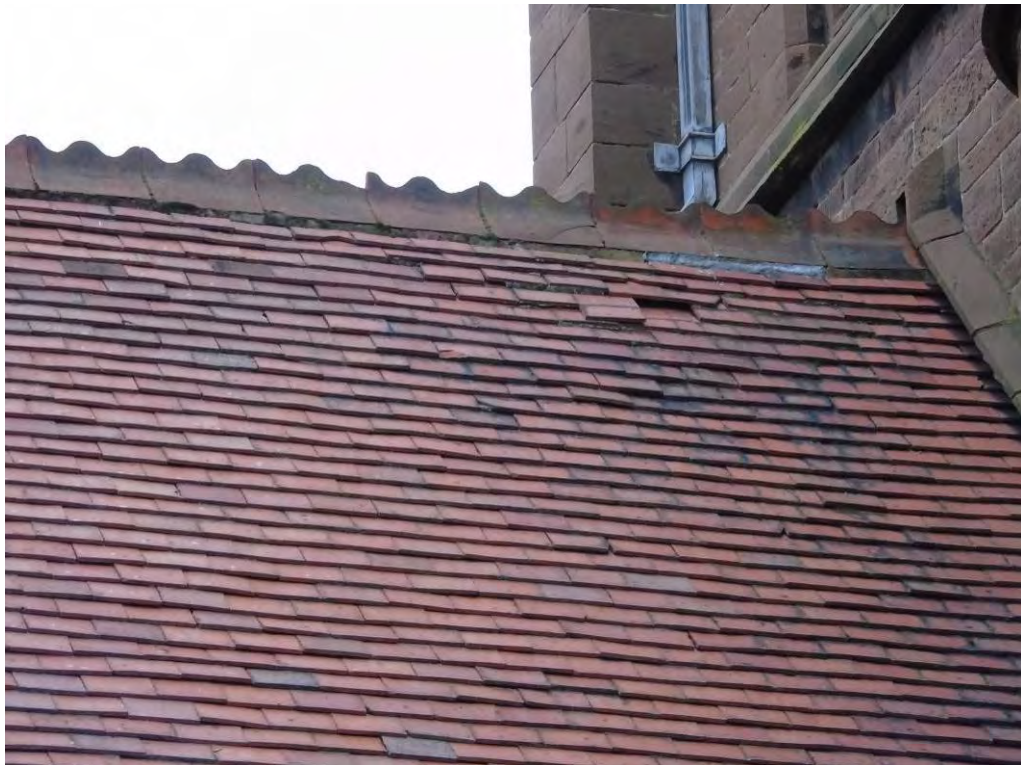
Nave south pitch. Detail of abutment to tower.

Missing tiles were noted particularly at the abutment to the tower. The first six or so courses beneath the ridge tiles appear particularly disrupted though further disrupted tiles are evident at the eaves location. There is also clear evidence of replacement

tiles having been inserted of different types and colours, although not radically different so as to be visually intrusive.

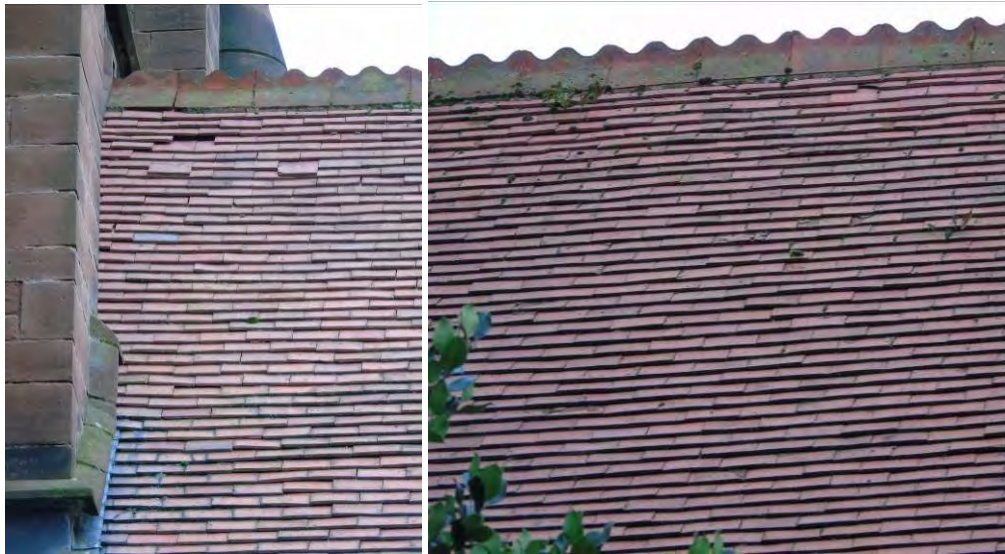
Nave north pitch details.

The nave north pitch takes prevailing weather from the estuary, its condition is worse than that to the south with copious missing tiles and evidence of replacement. Vegetation growth is also taking hold. It is in urgent need of renewal.

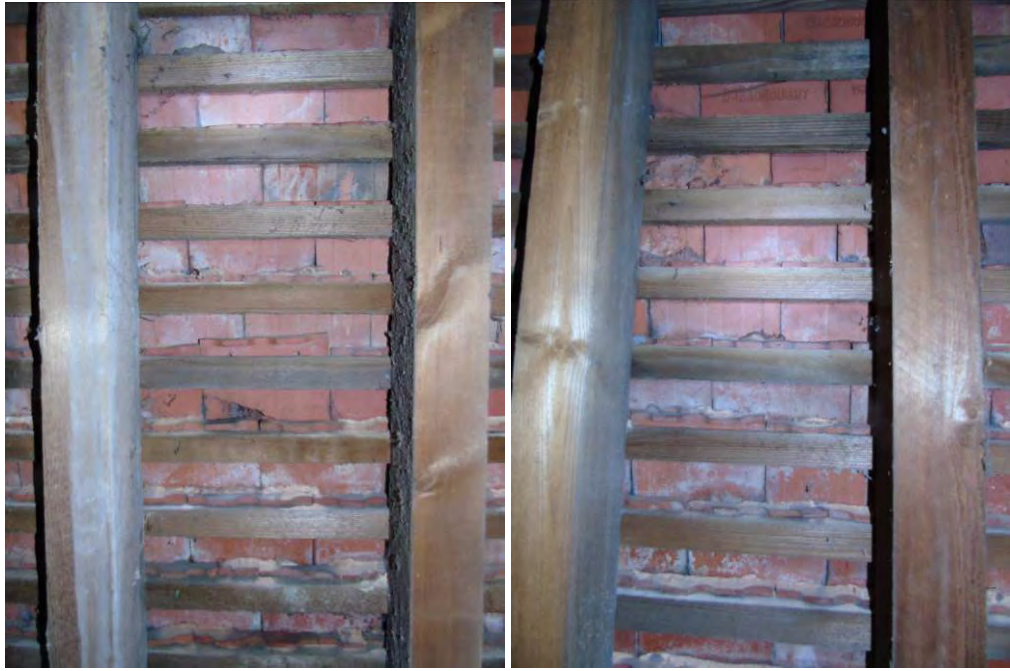
The roof is structured by four large purlins and rafters. There are no true trusses as such but tie beams with a king post and struts and braces supporting the first purlin. None of the tiles have been nailed. There is no felting under the tiles and the lime parging has spalled away. The roof is likely to be that installed at the time of the churches construction. It is also quite evident that a number of replacement tiles have been inserted throughout the roof.

Original tiles appear to have two nibs with ribs to the reverse face and are not brand marked. Replacement tiles by Dreadnought amongst others were quite clearly evident. Cracked and slipped tiles adjacent to the tower particularly were noted however the condition of the roof timbers appears to be generally good at the present time although the wallplate could not be inspected due to a section of masonry which is built up close to the eaves position. The roofspace also appears to be reasonably well ventilated due to openings at eaves positions.

Details of cracked, displaced and replacement tiles.

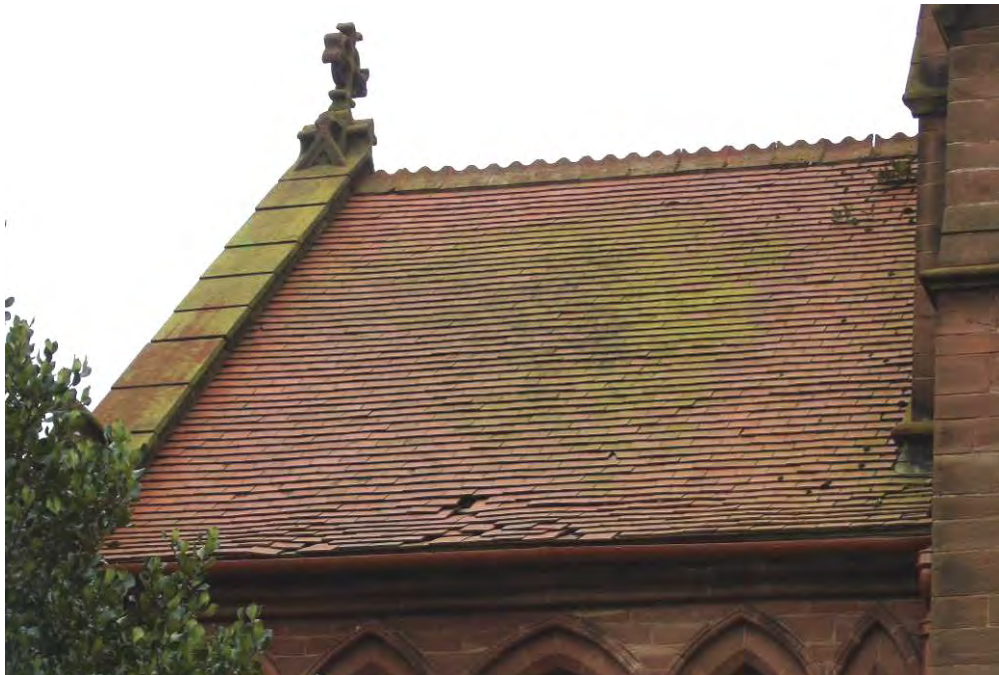
Sanctuary north pitch.

The sanctuary north pitch roof is in exceedingly poor condition and has a large opening section at the eaves. Vegetation growth is also taking hold adjacent to the

tower. Immediate urgent repairs are required to restrict the amount of water ingress possible through the failing roof prior to complete reroofing.

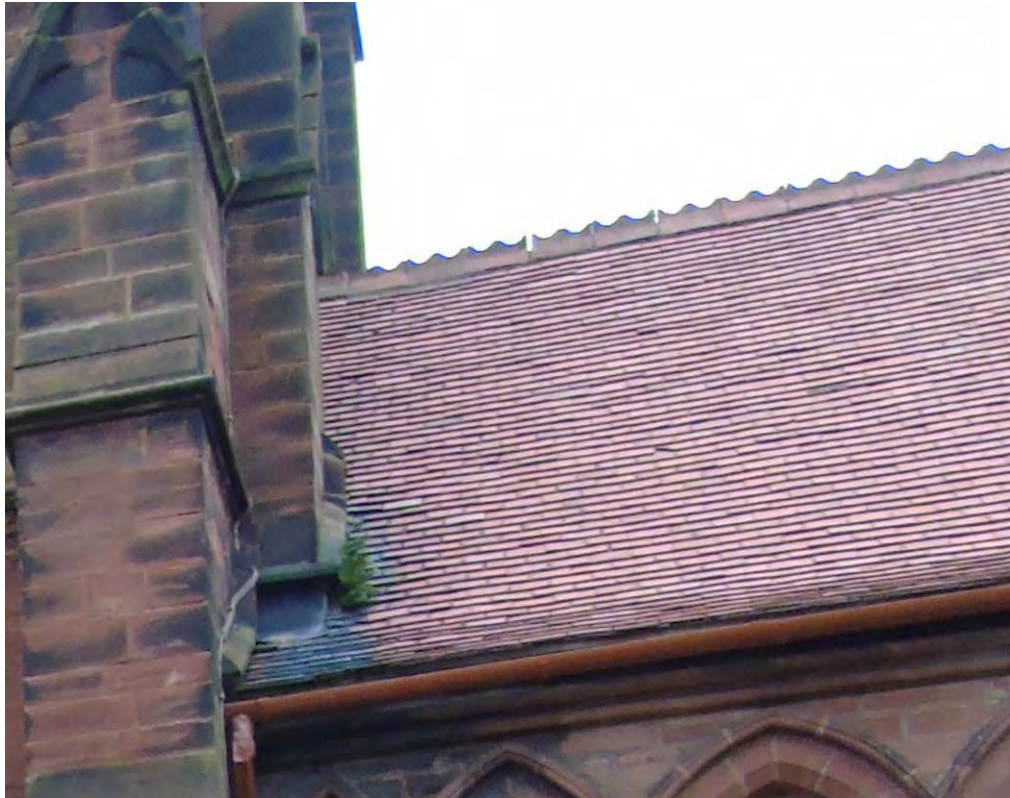
The sanctuary south pitch roof is in better condition than that to the north however cracked and disrupted tiles are clearly evident. Vegetation is also taking hold at the abutment to the tower and there are large openings between crests.

Sanctuary south pitch.

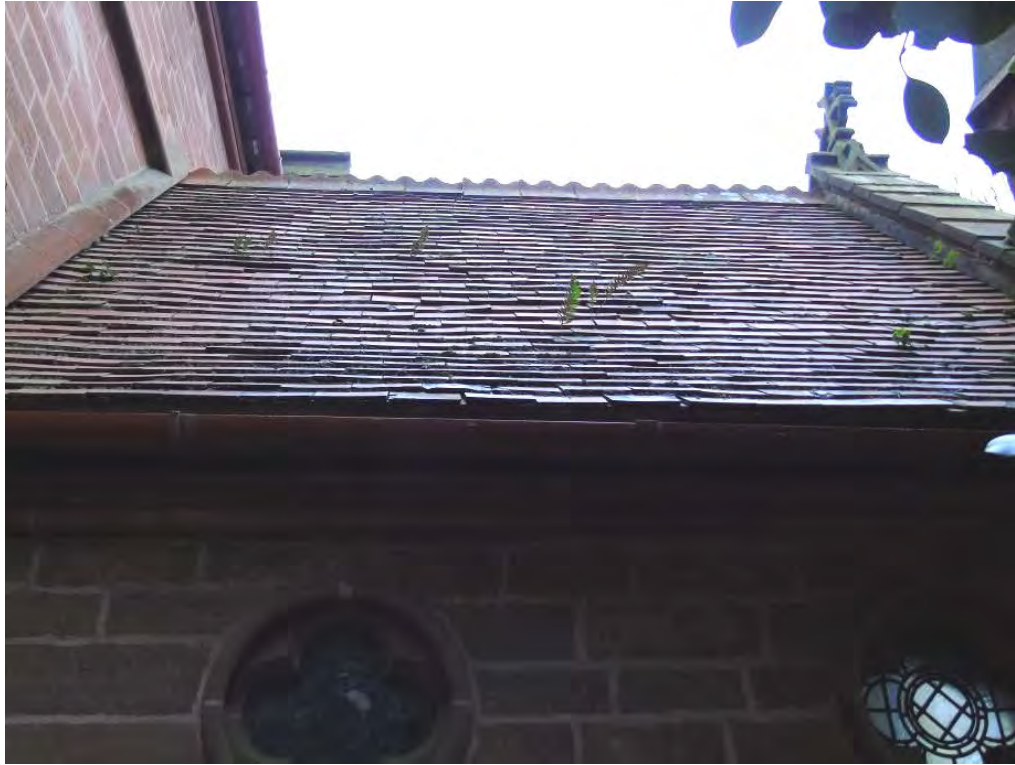
North porch has a simple pitched tile roof as seen elsewhere. Again disrupted, cracked and missing tiles are evident to both east and west pitches as well as light vegetation growth. Reroofing is now necessary.

Vegetation growth is particularly evident to the east pitch of the north porch due to the proximity of the adjacent holly tree which emphasises the need for radical pruning or its removal.

North porch east pitch.

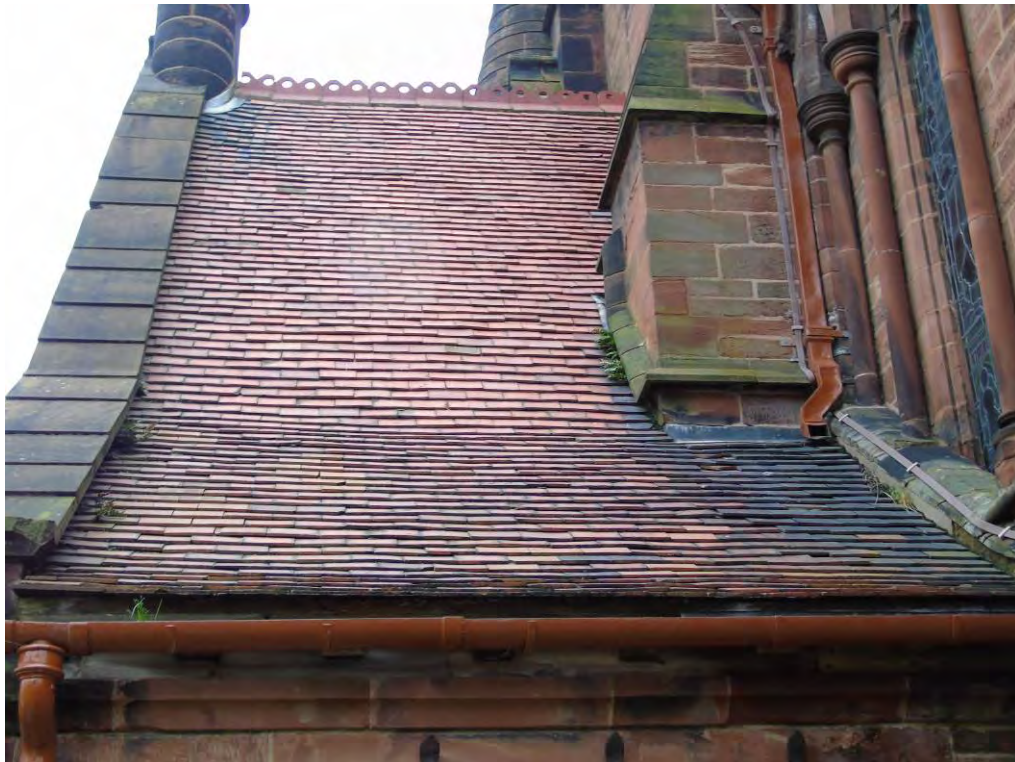
Vestry and organ chamber, east pitch.

locations and to the coping stones to the south gable. The flashing detail across the sanctuary window is particularly poor and cement flashing is spalling and failing in this location. High level access would be required to ascertain the detail for the weathering of the coping stone as it abuts the sanctuary window and consideration would need to be given as how this could be improved as part of any re-roofing project.

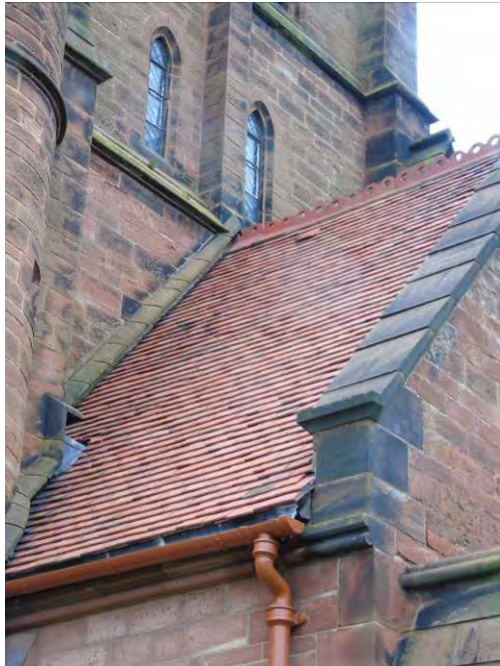
Vestry and organ chamber, west pitch.

This pitch appears to be in better condition to that at the east and is of a single steeper pitch, however disrupted and missing tiles are still evident and re-roofing should be undertaken as part of the whole re-roofing of the church building generally.

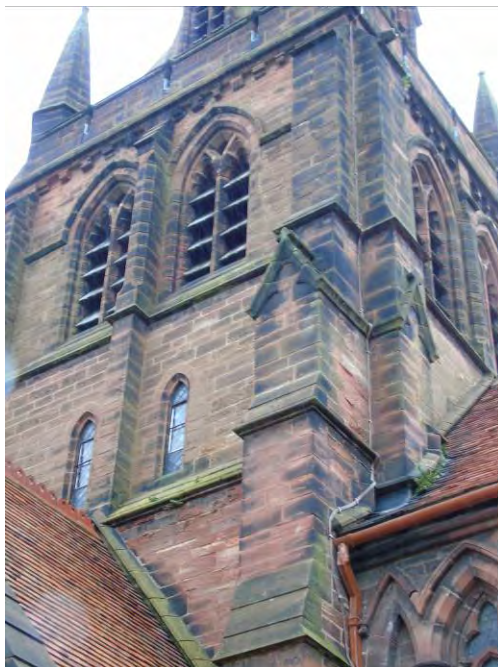
South elevation of tower. Note vegetation growth beneath lancet windows.

Erosion to the masonry is particularly pronounced to the south elevation beneath the window openings and above the roof to the vestry where vegetation is taking hold and excessive rainwater run-off is occurring. Similar erosion of masonry was noted to the east facing buttress in this area. Localised repointing and removal of vegetation is necessary and should be undertaken as part of any re-roofing project.

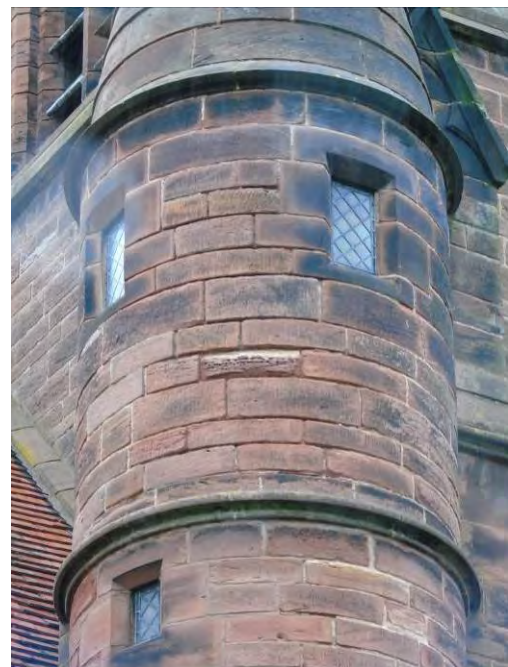
Open mortar joints and wind erosion to spiral stair.

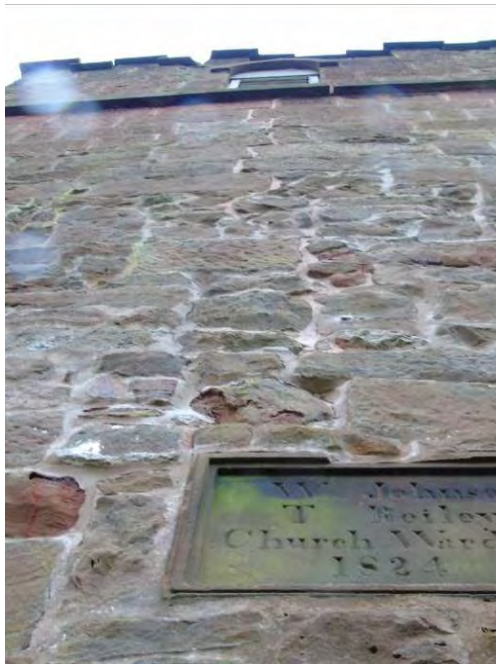
Cement pointed movement crack.

Some movement cracking is also noted which has been pointed in cement and appears not to have not moved significantly since repointing.

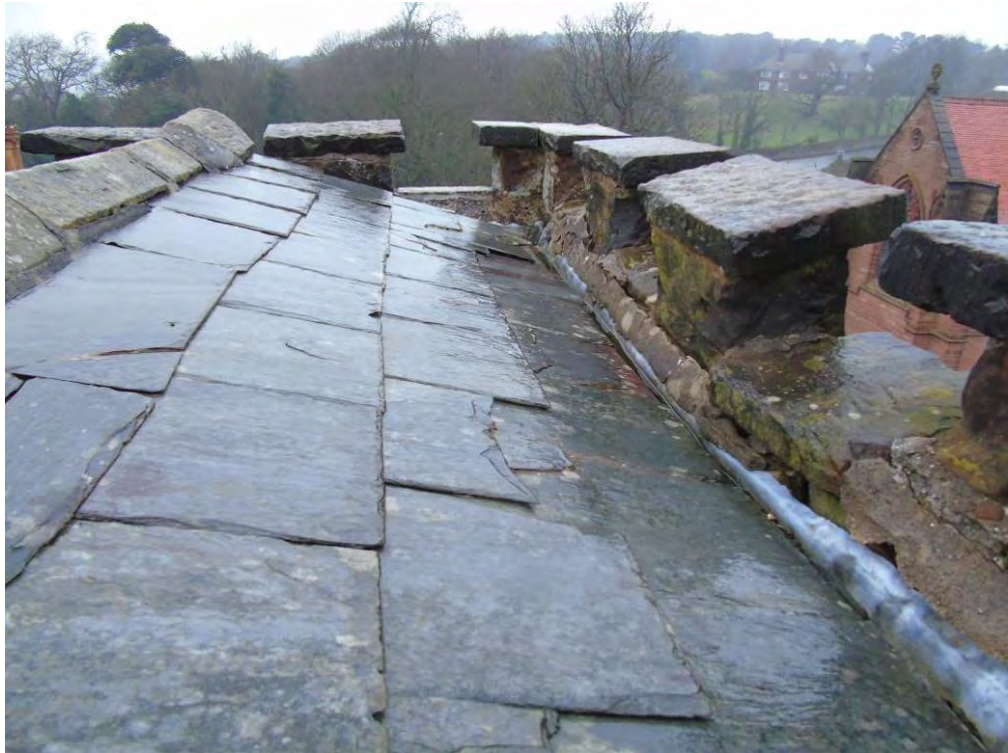
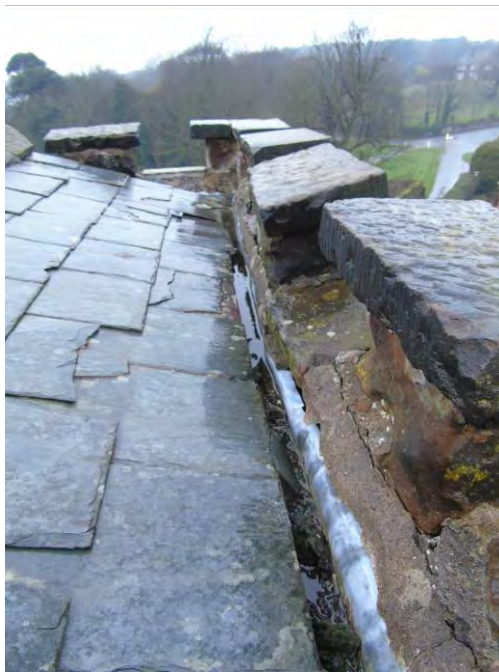
The old tower roof is pitched but with a slate finish and stone ridge tiles. The pitch is particularly shallow and much of the slate has been either mortar repaired or cracked. The gutter is a very shallow and narrow lead gutter which is substantially blocked with vegetation and silt and the lead flashing to the parapet wall is detached. Merlons that were accessible from the roof hatch moved slightly when tested but are reasonably stable presently. Roof repair works are advisable to this structure before serious and

Roof and parapet gutter to the Old Tower.

more substantial repairs become necessary. At the very least the perimeter gutters should be cleared out and the lead refixed. Re-roofing would be the ideal solution.

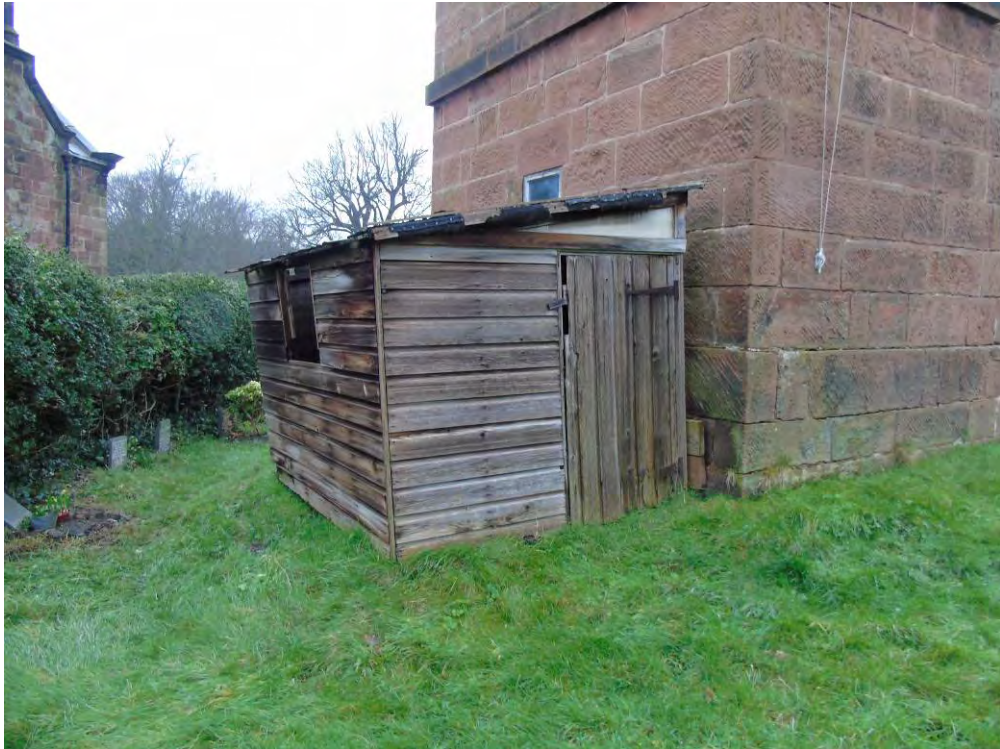
There is a timber shed located to the west side of the old tower which is in a dilapidated state with failed roof covering and detaching west timber panel wall. It should be removed or replaced.

Dilapidated shed abutting the Old Tower.

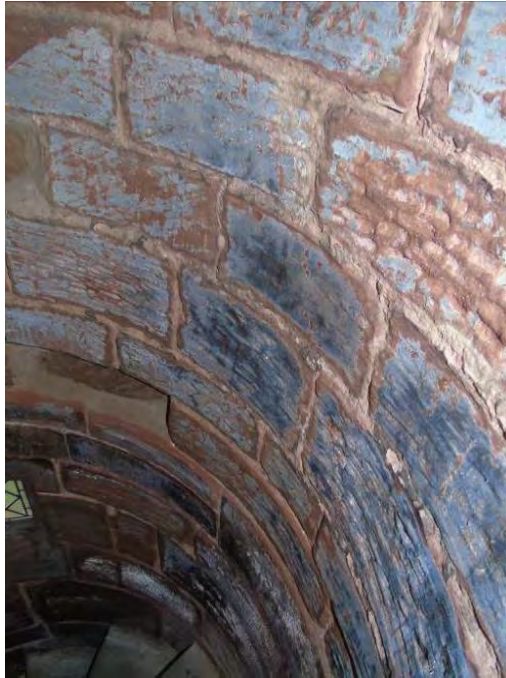
Interior of spiral staircase. Note moisture to masonry face.

The bell ringing chamber is accessed via a spiral staircase with an external door to the south side of the church. The stair is in sound condition, there is no handrail or rope, however it is a particularly small spiral staircase and you are able to brace yourself against the masonry. Walls are of fairfaced red sandstone. Some moisture / condensation was noted to the internal face of this masonry.

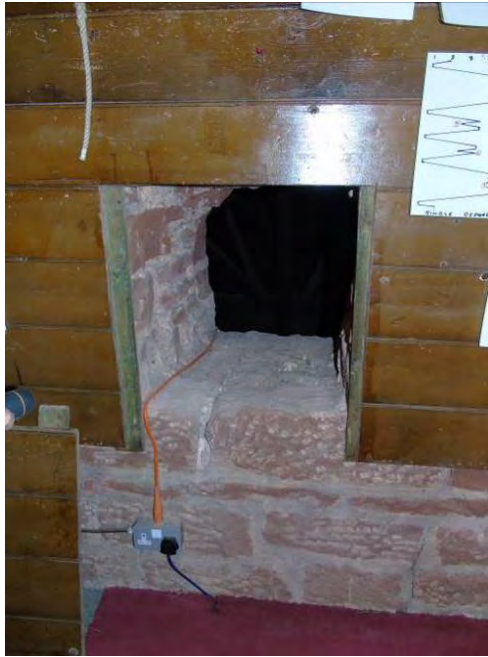
Roughly formed opening into nave roof void.

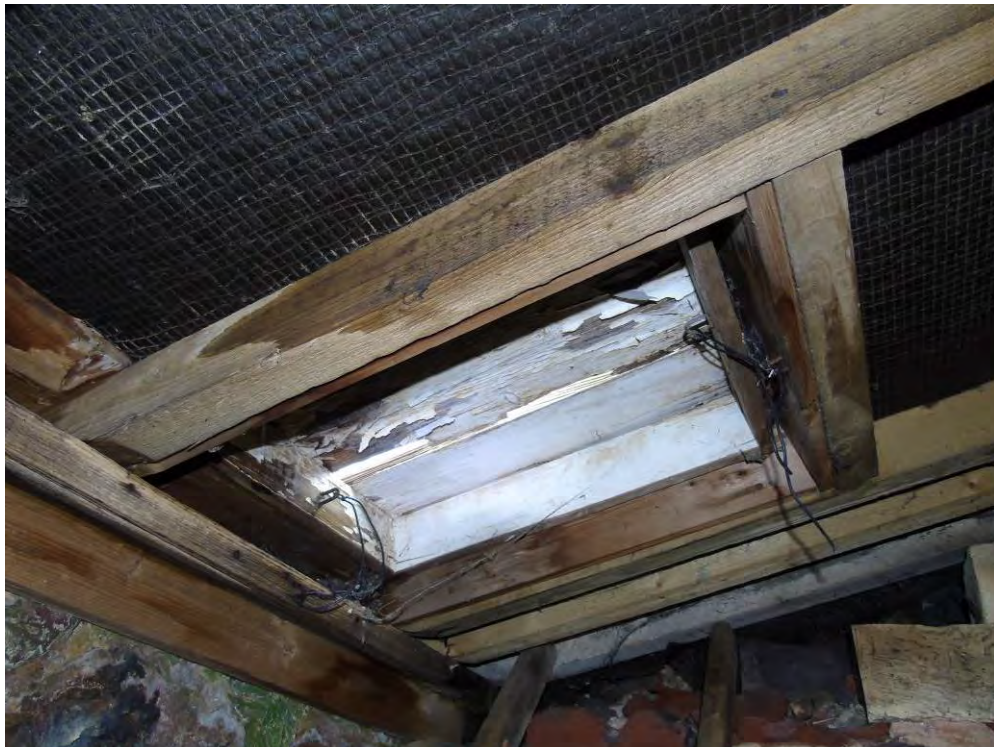
The roof has been underdrawn with modern bituminous felt which has been pierced to the east side in several locations and there is also a roof hatch on this pitch which is of timber and is heavily decayed and in need of replacement.

Roof access hatch decayed.

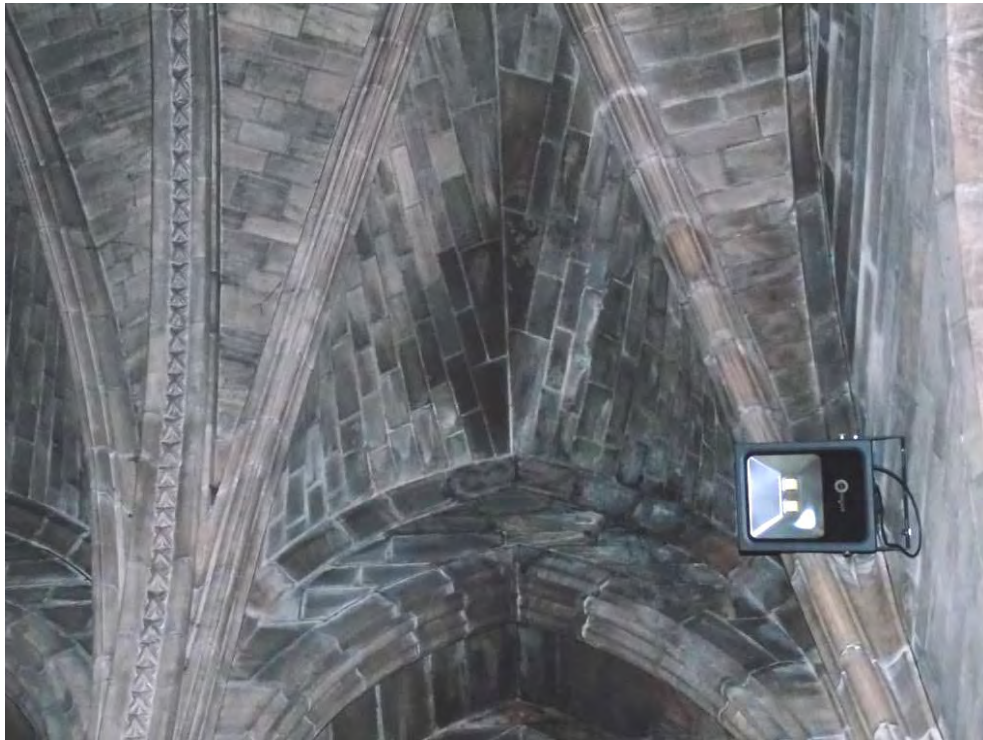
Water damage to vault within sanctuary.

The general condition of all of the stone vaults appears to be good. However water staining and salt precipitation was noted in both the sanctuary area and the nave, the most significant area of which is within the sanctuary immediately above the altar/reredos and to the south side where the sanctuary abuts the tower. This relates to a downpipe and flashing detail externally which is in poor condition / poorly designed.

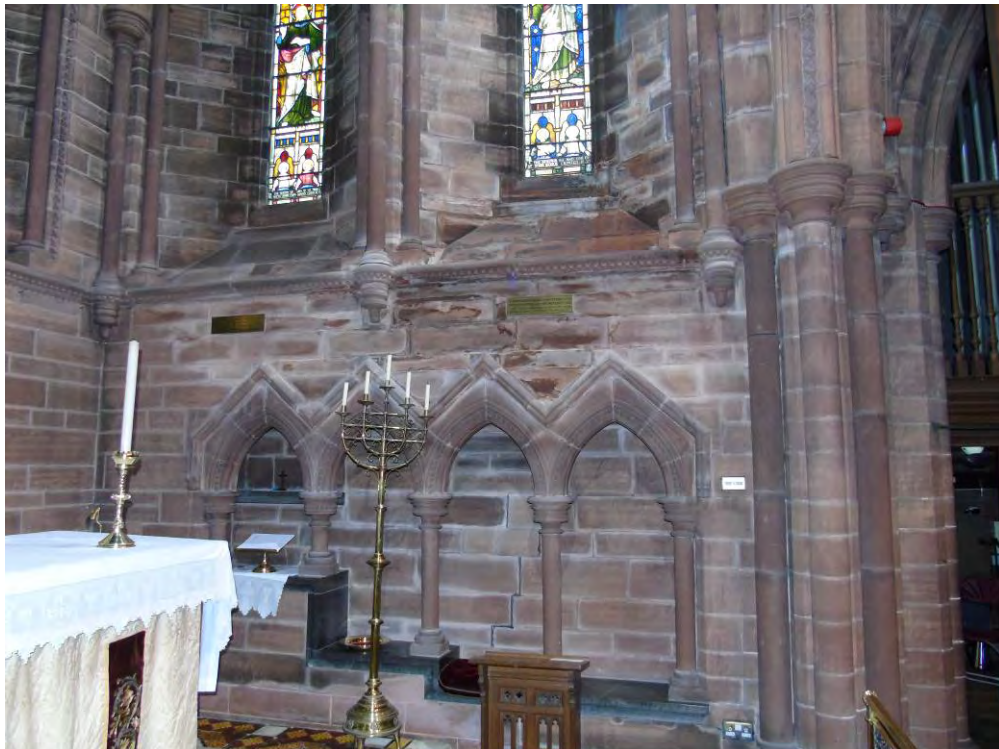
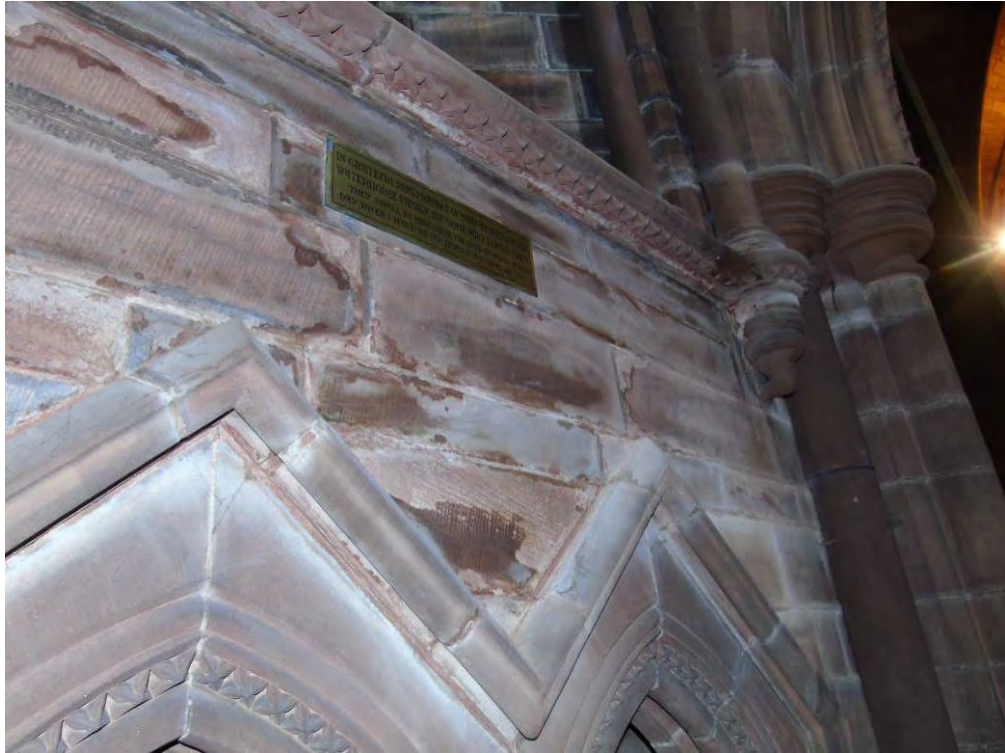
Water damage within the sanctuary however is of greater concern and this is most notably to the south wall above the sedilia. This relates to the abutment of the vestry and an awkward arrangement of downpipe and guttering. This also corresponds with the area of water damage noted to the vaulting in this area. The water damage is such that the face of the masonry has become friable, particularly to the area around the window to the west side of this wall and mortar joints are beginning to fail. Some of the mortar may be cement which is exacerbating the decay to the stonework. Once roof repairs are carried out this wall should be allowed to dry thoroughly before considering the works required to repair it. The gentle removal of loose material and repointing is likely to be required.

Water damage within sanctuary.

Detail of water damage within sanctuary.

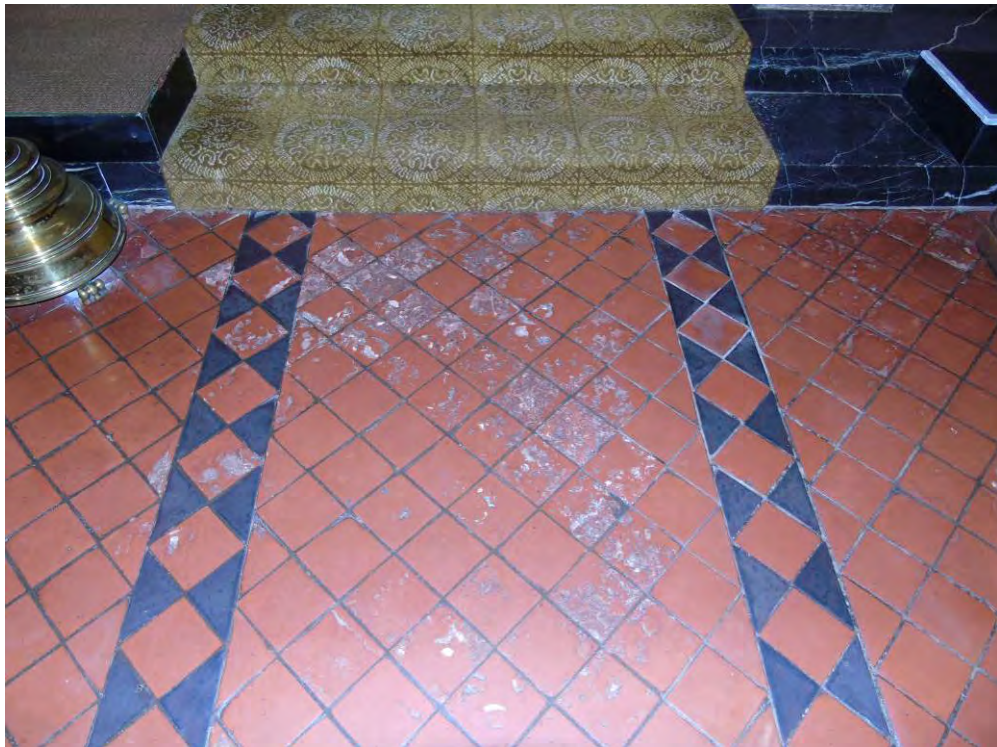
The nave has a geometric tiled floor at the west end around the font and down the central aisle, pew areas are level with the aisle but have timber floors. The quarry tiles at the east end in front of the choir steps show some erosion and there is some evidence of tiles having been reset/replaced around the pulpit. Damage to the tiles may well be due to ground water issues particularly at the east end as efflorescence is noted.

Damaged floor tiles within nave.

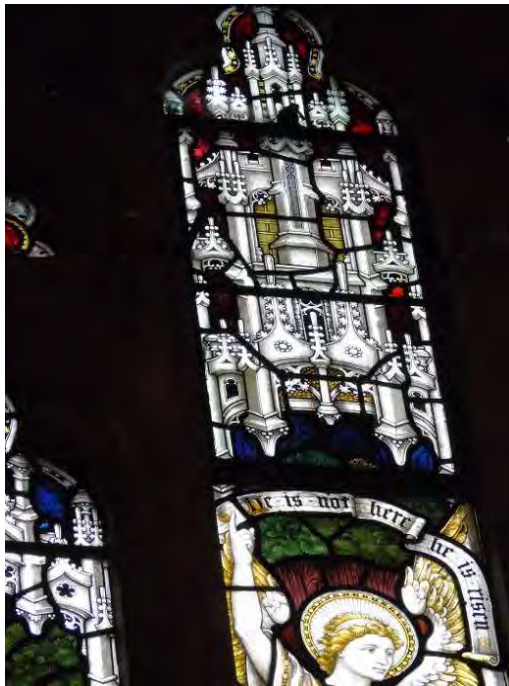
Detail of sealed opening window within nave.
