INSPECTION OF CHURCHES MEASURE 1955

PARISH OF ST BARTHOLOMEW, THURSTASTON

DRAFT QUINQUENNIAL INSPECTION REPORT

JANUARY 2016

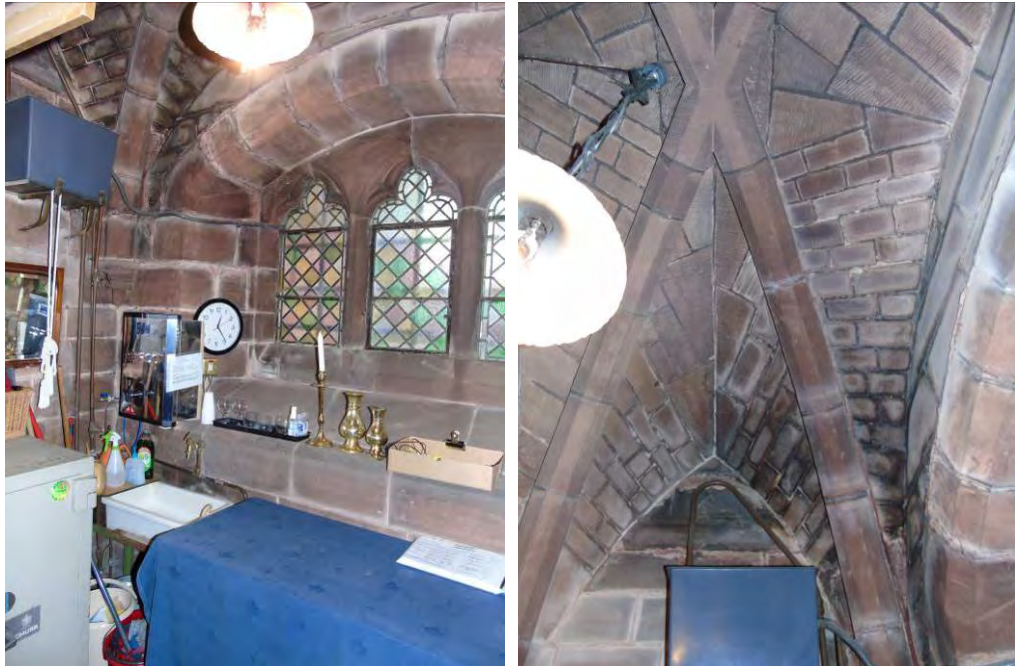
The vestry / organ chamber has a woodblock floor which although a little uneven appears to be sound. Ceilings in the vestry are stone vaulted, however the majority of the ceiling is occupied by the organ and therefore could not be fully inspected. What could be observed appeared to be in sound condition though some water damage was noted particularly at the east end where the defective roof and downpipe has been noted. Walls are also of red sandstone with water damage at the east end.

Water damage within vestry.

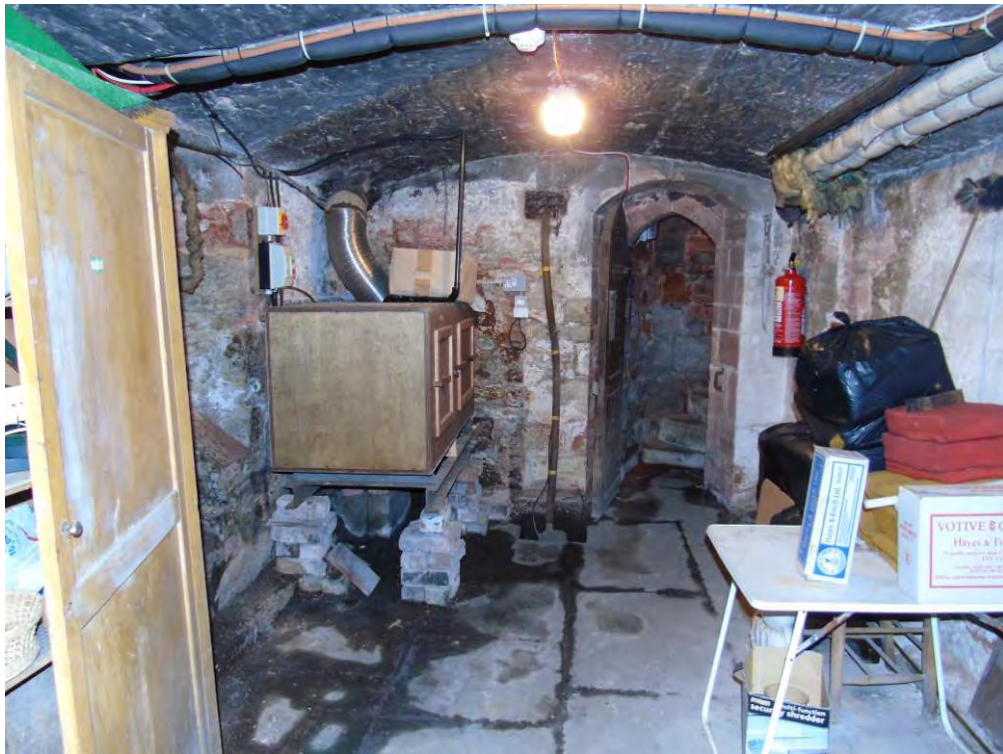
The organ blower is supported off brick piers which have just been loosely laid. This is obviously to lift the blower off the ground where moisture could affect it. The piers do appear a little unsubstantial and not ideal. They would ideally be rebuilt.

The heating chamber. Note piers to organ blower.

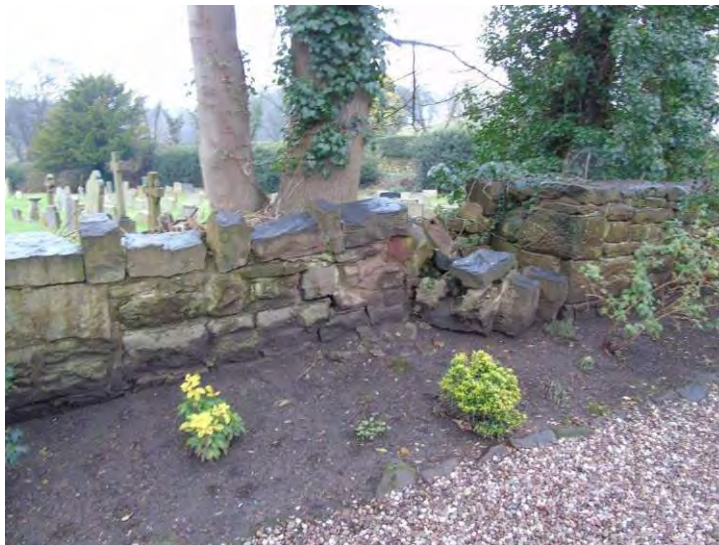
The low boundary wall is to all intents and purposes a dry stone. The proximity of mature trees growing against this low section of wall is causing some distortion to it which is causing it to lean and a small section of which has collapsed about midway along its length which is in need of rebuilding. Removal of the tree should be considered before rebuilding the wall.

Collapsed section of low south boundary wall.

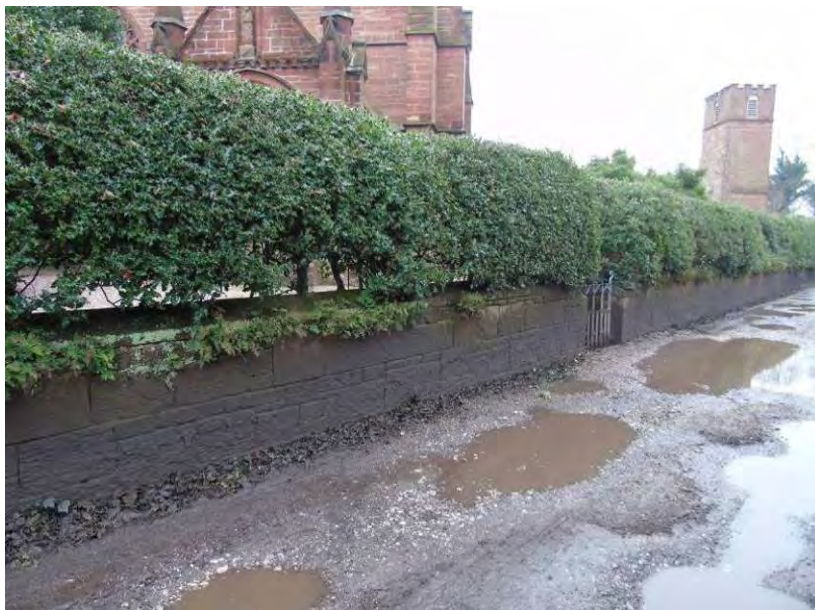
The west boundary again is a continuation of the more formal boundary walls to the east and north side of the church and again pruned hedgerows grow tight up against it, however a considerable amount of vegetation growth is taking hold beneath the coping stones which should be removed and localised repointing undertaken. Excessive ivy growth particularly to the south section of walling should also be removed and the condition of the wall assessed.

Vegetation growth to west boundary wall.

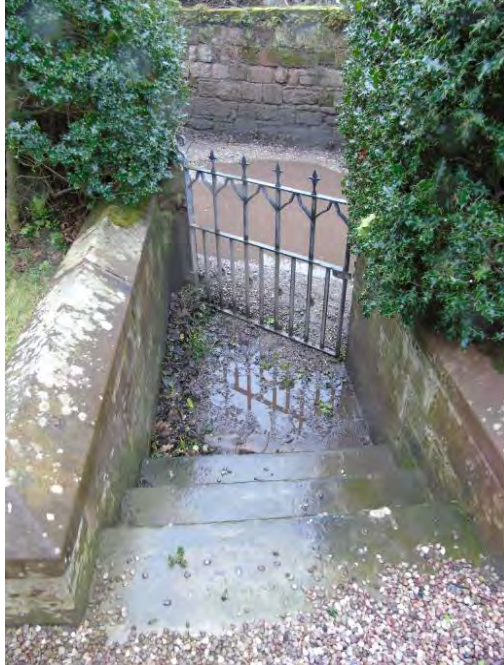
There is a gated access through the west wall. The metal gate which appears to be jammed due to the gravel build-up on the adjacent road. There is also a considerable amount of standing water in this area. Some drainage improvements to this area may be considered as well as repair and redecoration of this metal gate.

West boundary gate.
