INSPECTION OF CHURCHES MEASURE 1955

PARISH OF ST BARTHOLOMEW, THURSTASTON

DRAFT QUINQUENNIAL INSPECTION REPORT

JANUARY 2016

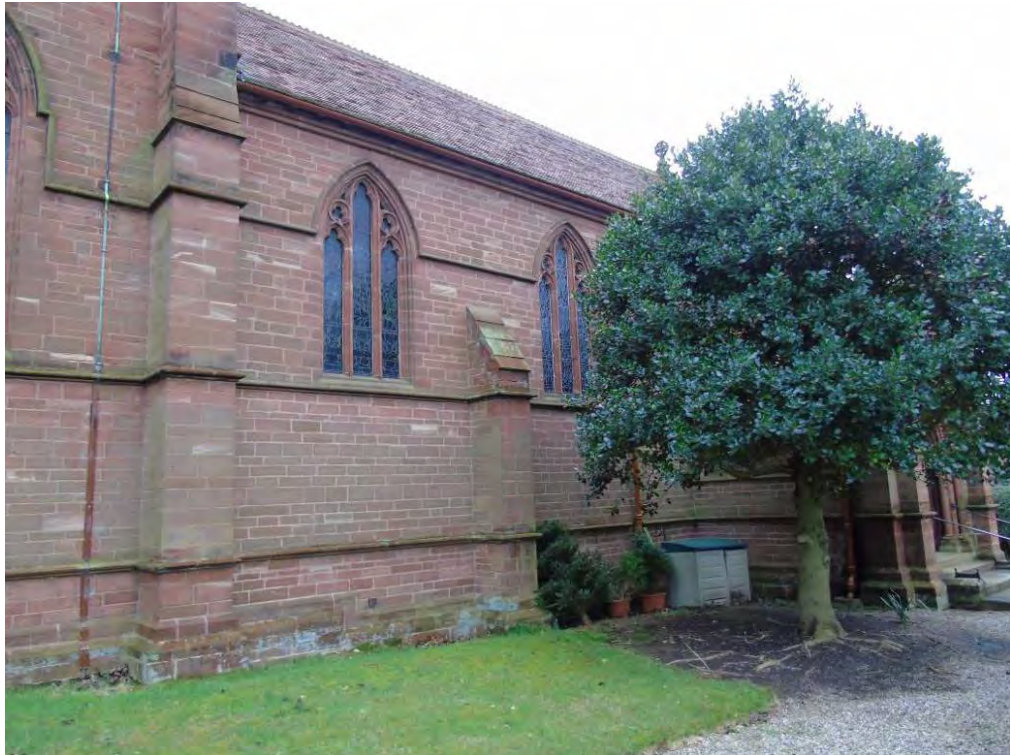
Nave North Elevation

Some erosion to the masonry is noted to the central buttress between the two windows to this elevation, this is presumably due to the run off from the weatherings. Some localised repointing works may be advisable. It was also noted that the wall appears to be generally pointed with a thin bed of cement mortar whereas the spalling away lime can be seen behind. Presently this isn't causing excessive erosion of the masonry.

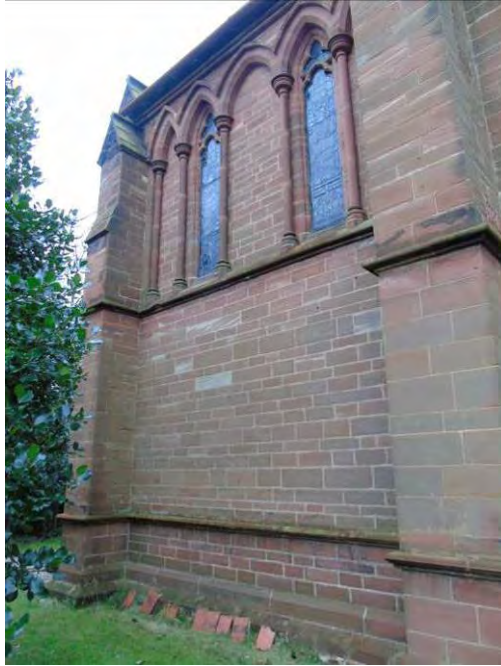
This elevation comprises a single bay with two single lights inset with blind arcading to either side with plain walling masonry beneath. Again the masonry is pointed with relatively shallow cement mortars but the masonry appears to be weathering generally very well.

Chancel north elevation.

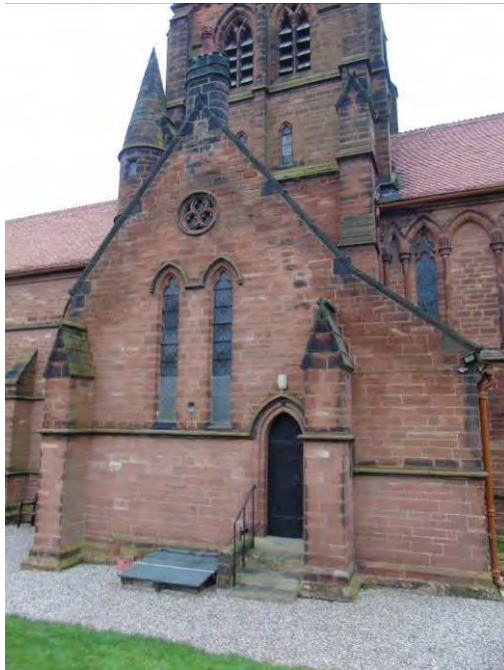
All again is pointed with a shallow cement mortar and some excessive erosion to the masonry is noted to the high level sections of the gable. The position of the flue within the wall is also quite evident due to the sulphate staining to the masonry that follows the line of the flue.

Vestry, south elevation.

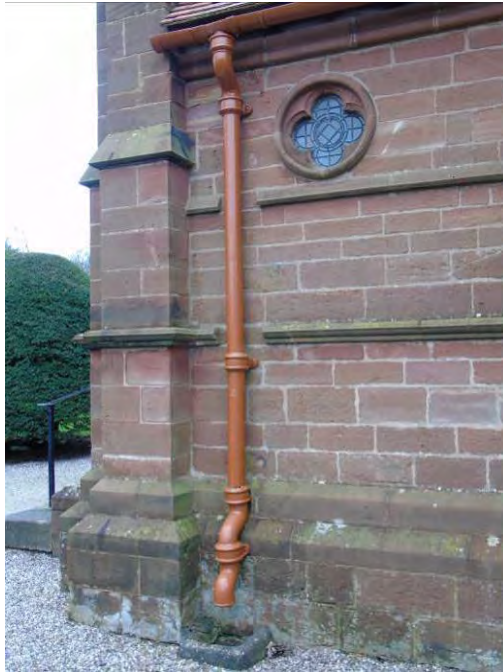
North porch west downpipe.

The downpipe to the west side of the north porch has its shoe set particularly high relative to the gulley and the section over the plinth is tight against the masonry. An additional section of pipe should be inserted to lower the shoe down into the gulley and suit the plinth offset. Downpipes have shoes and discharge into open gulleys. Many of the gulleys are blocked with leaf litter and silt and should be cleared.

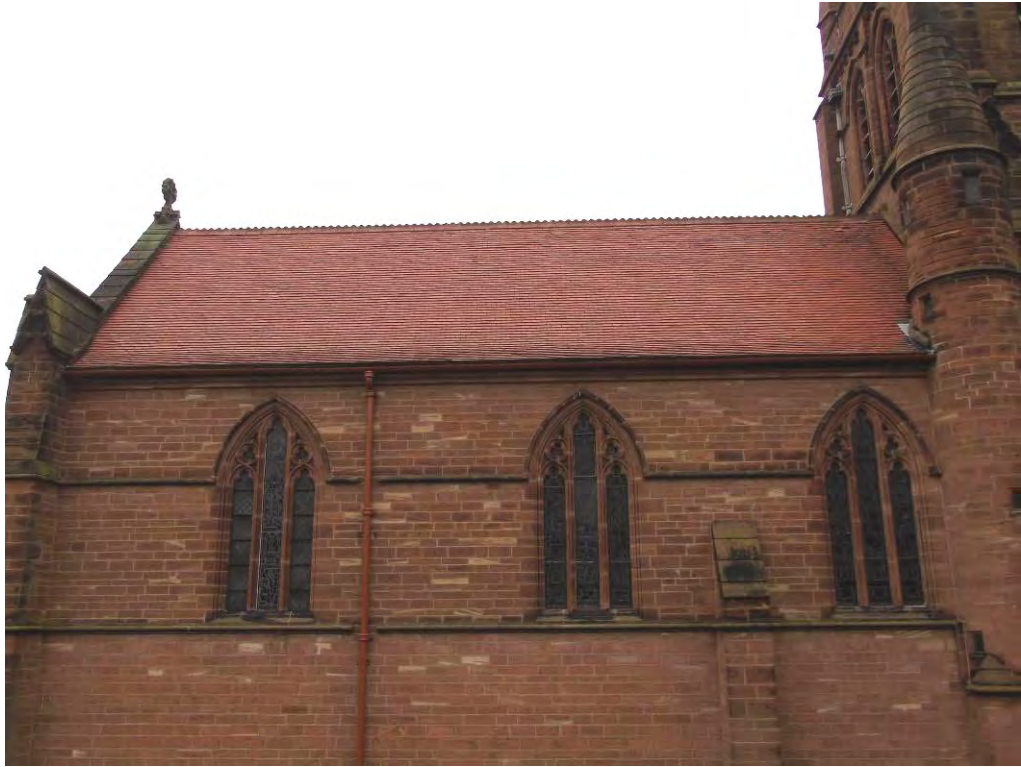
Nave south pitch. General photograph.

Missing tiles were noted particularly at the abutment to the tower. The first six or so courses beneath the ridge tiles appear particularly disrupted though further disrupted tiles are evident at the eaves location. There is also clear evidence of replacement

tiles having been inserted of different types and colours, although not radically different so as to be visually intrusive.

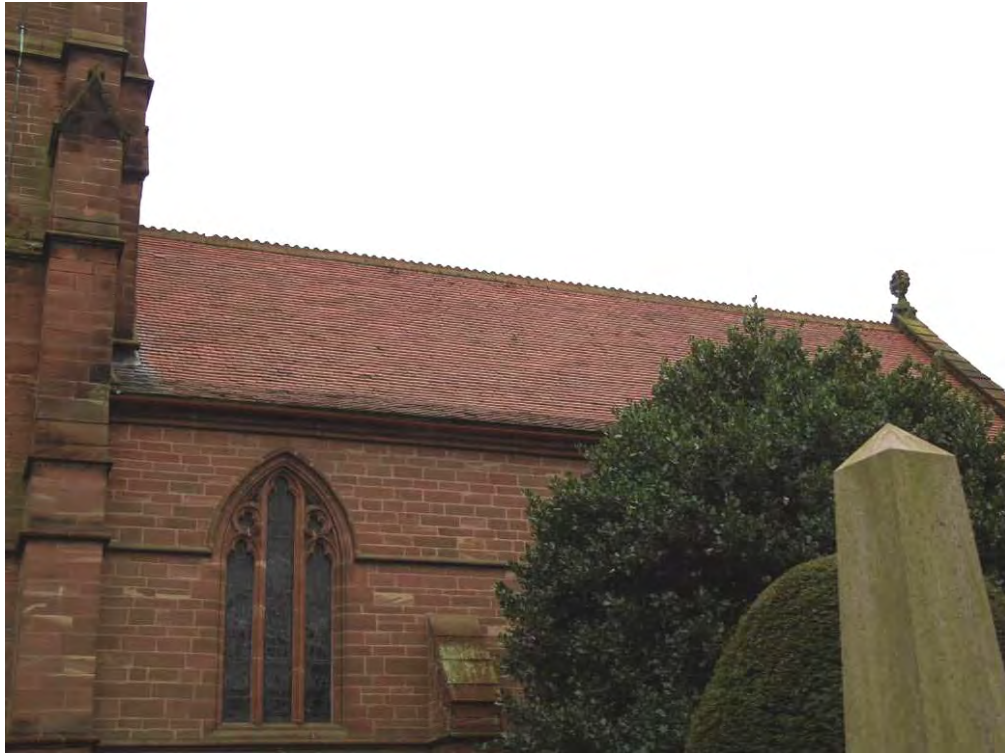
Nave north pitch. General photograph.

The nave north pitch takes prevailing weather from the estuary, its condition is worse than that to the south with copious missing tiles and evidence of replacement. Vegetation growth is also taking hold. It is in urgent need of renewal.

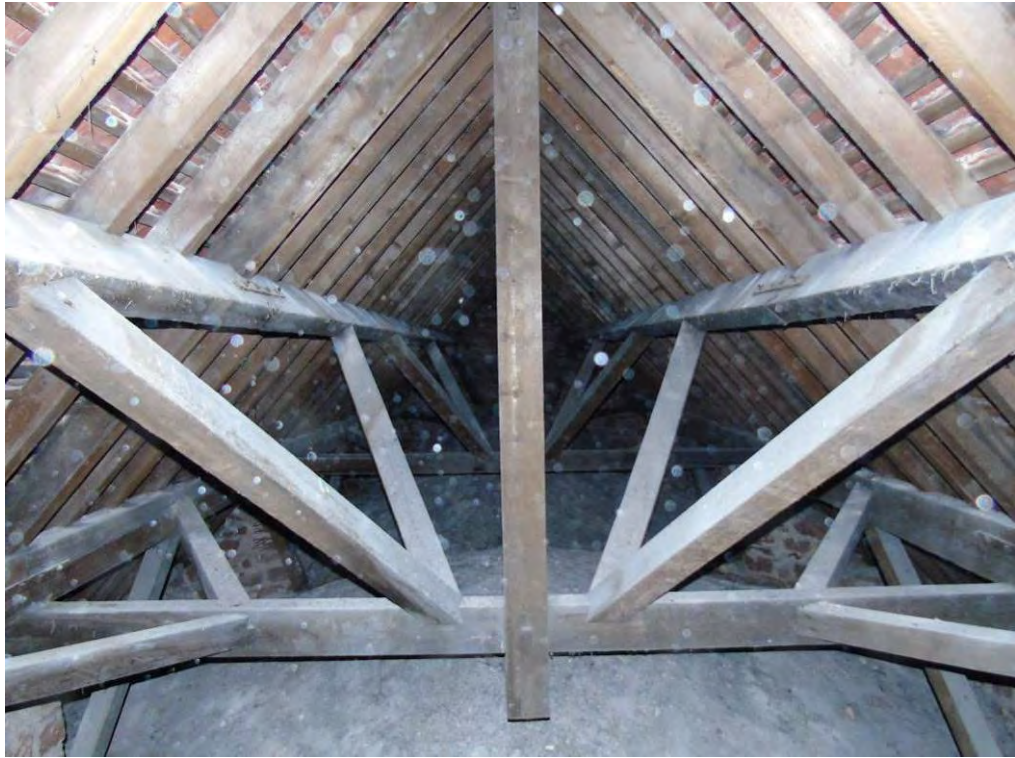
Nave roof space. General photograph.

The roof is structured by four large purlins and rafters. There are no true trusses as such but tie beams with a king post and struts and braces supporting the first purlin. None of the tiles have been nailed. There is no felting under the tiles and the lime parging has spalled away. The roof is likely to be that installed at the time of the churches construction. It is also quite evident that a number of replacement tiles have been inserted throughout the roof.

Original tiles appear to have two nibs with ribs to the reverse face and are not brand marked. Replacement tiles by Dreadnought amongst others were quite clearly evident. Cracked and slipped tiles adjacent to the tower particularly were noted however the condition of the roof timbers appears to be generally good at the present time although the wallplate could not be inspected due to a section of masonry which is built up close to the eaves position. The roofspace also appears to be reasonably well ventilated due to openings at eaves positions.

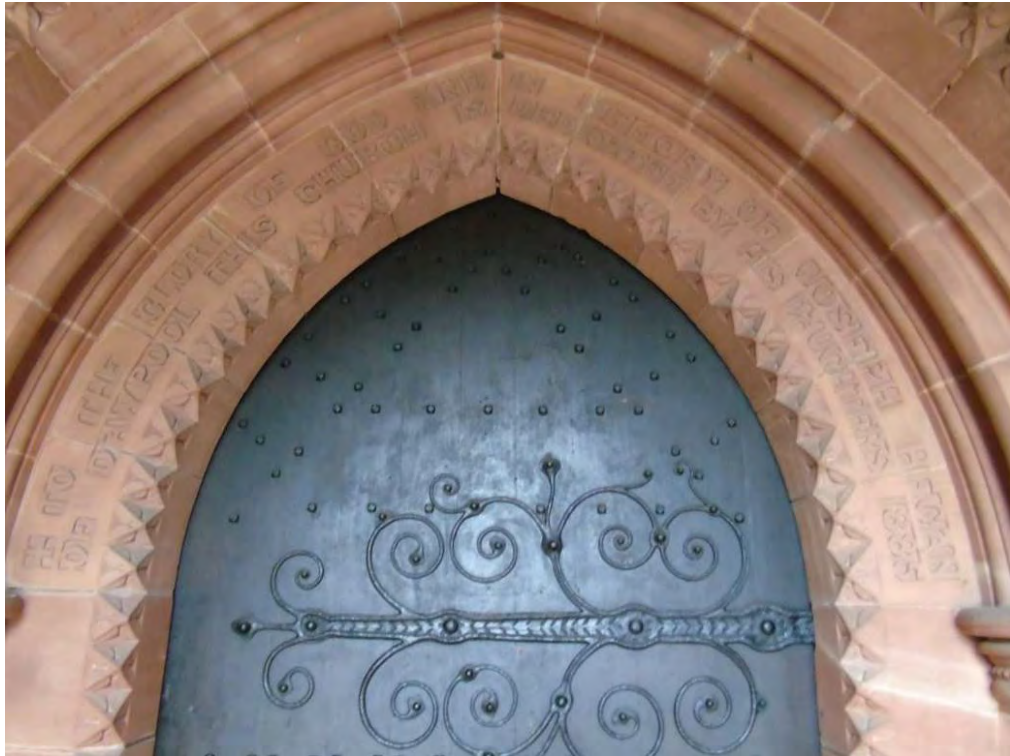
North porch door and opening.

The door entrance within the porch to the north wall is particularly finely carved with flower crockets and dog tooth detailing and an inscription above. All appears to be sound.

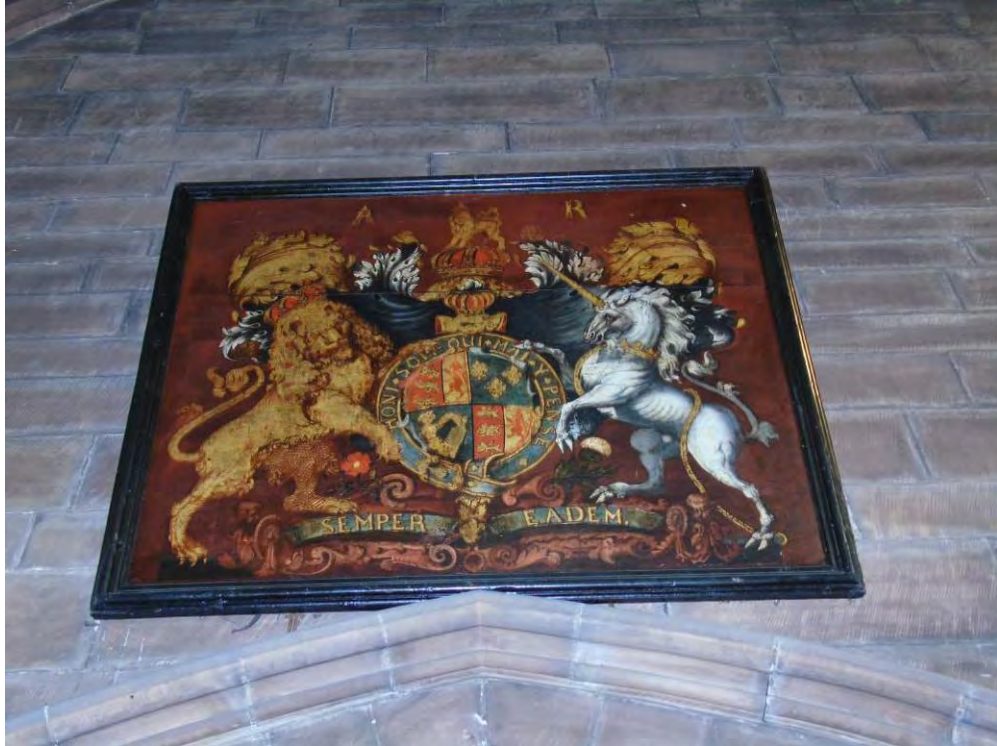
A coat of arms of Queen Anne is located over the north door entrance, it is constructed of timber which is painted. One of the boards to this coat of arms has opened up slightly and the paint finish doesn't appear to be in particularly fine condition, however visually it appears to be sound at the present time.

Queen Anne coat of arms

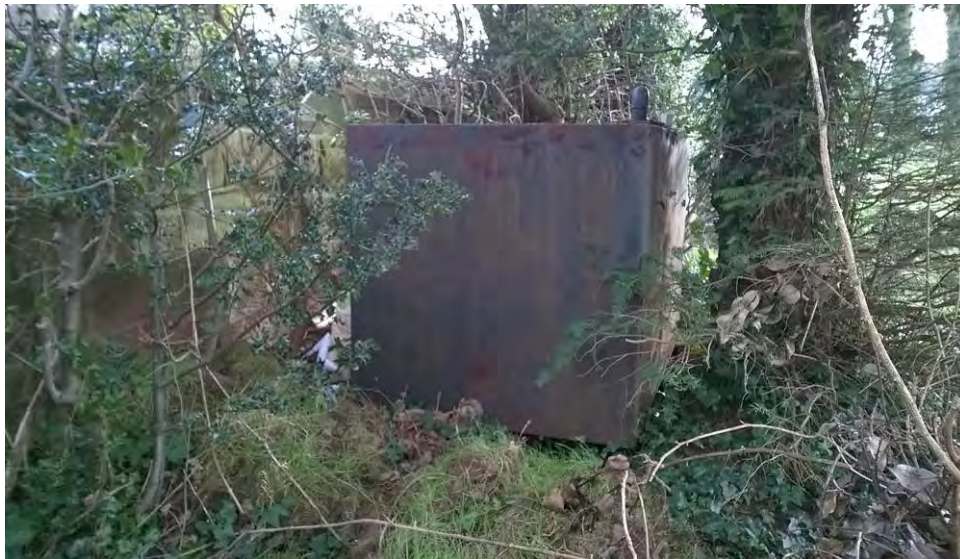
The oil tank.

The boiler is oiled fired. The oil tank is located to the south of the chancel. It is corroding and may require renewal / repair.

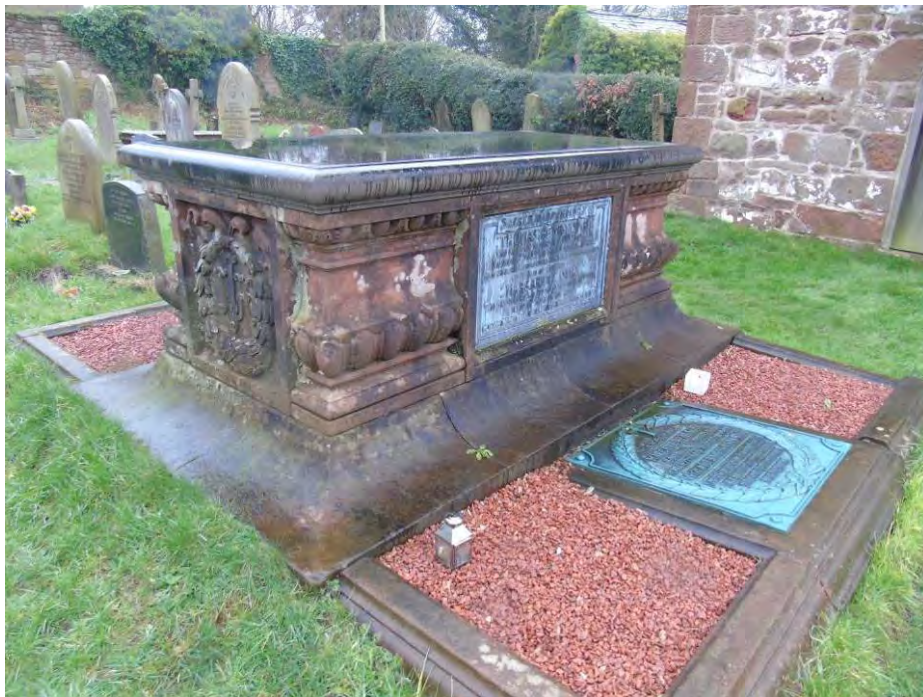
The churchyard has a number of substantial monuments located to the south side, most notably that to Thomas Ismay and his wife located adjacent to the old tower. It is a substantial chest tomb which is carved with wreaths and inlaid bronze plaques.

Ismay tomb.
